LITTLE COLORADO RIVER BASIN ARIZONA-NEW MEXICO

APPENDIX III EROSION & SEDIMENT AND FLOODING

December 1981

LITTLE COLORADO RIVER BASIN
COOPERATIVE STUDY

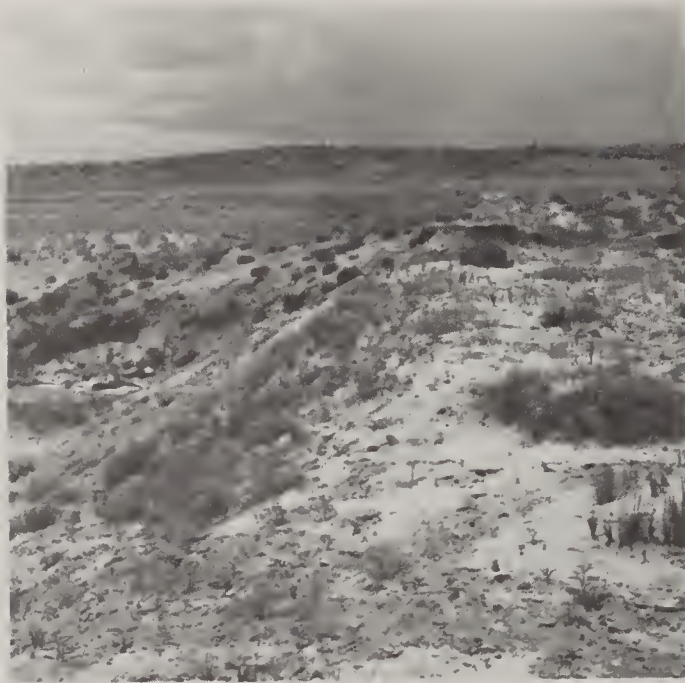
Photo 1-33. Failed water spreader, Muddy Wash, Mexican Springs, New Mexico (San Juan Basin). View is looking down the crest of the dike, showing breached section and storage area completely filled with sediment.

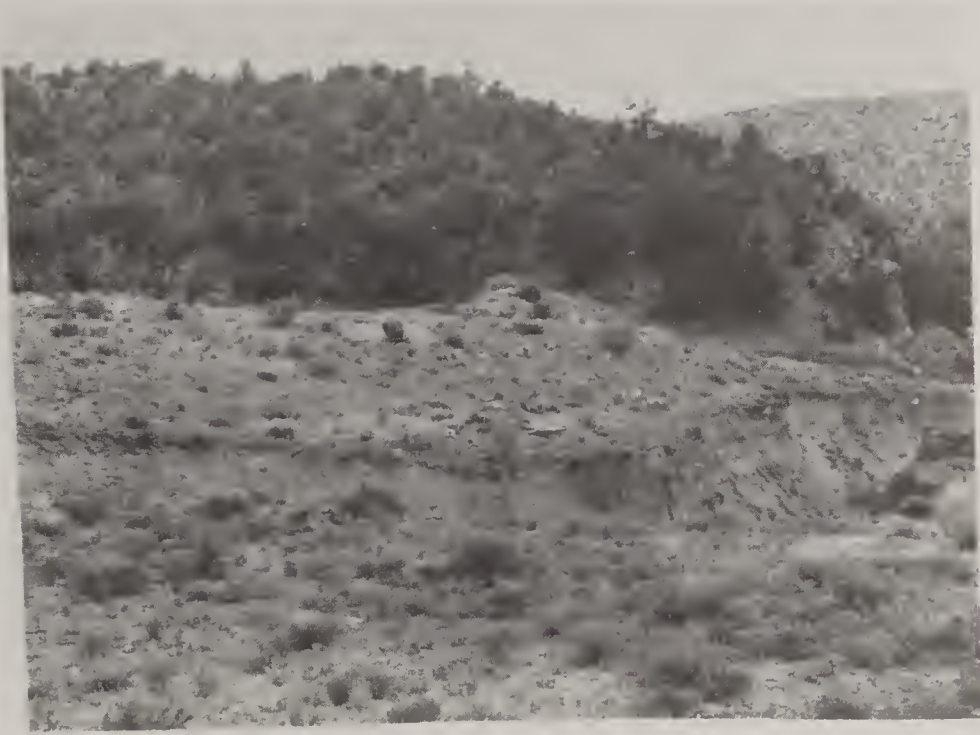
Photo 1-34. Breached emergency spillway of a debris basin, Navajo Indian Reservation, Apache County, Arizona. The dam is shown in center of photo. A stable spillway could have been provided at this site with little extra expense by placing the spillway through rock on the hill.

Photos 1-34 and 1-35 show the failure of a debris basin from breaching through a poorly located structure. In contrast, Photos 1-36 and 1-37 show the positive benefits from proper site selection.

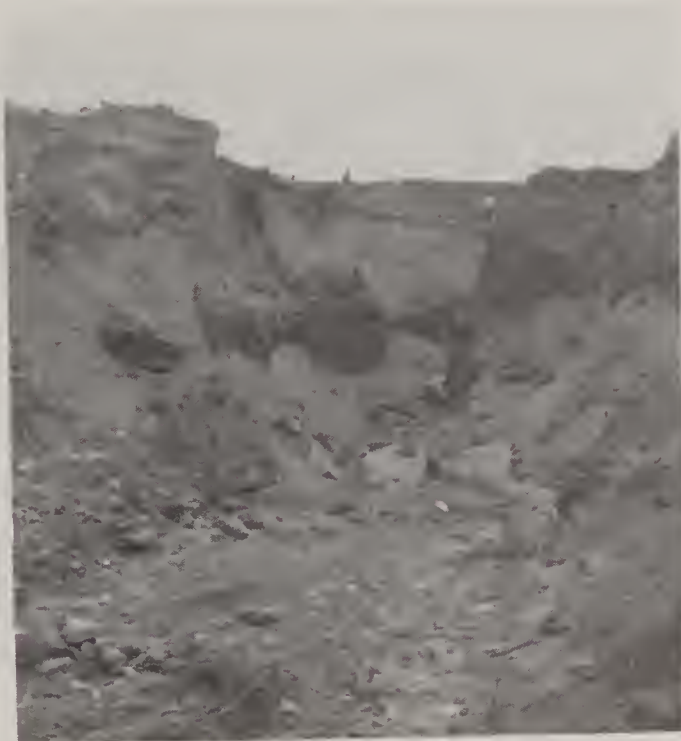
Photo 1-35. Breached emergency spillway of debris basin shown in Photo 1-34. View is looking upstream. People in the photo are standing on original spillway crest.

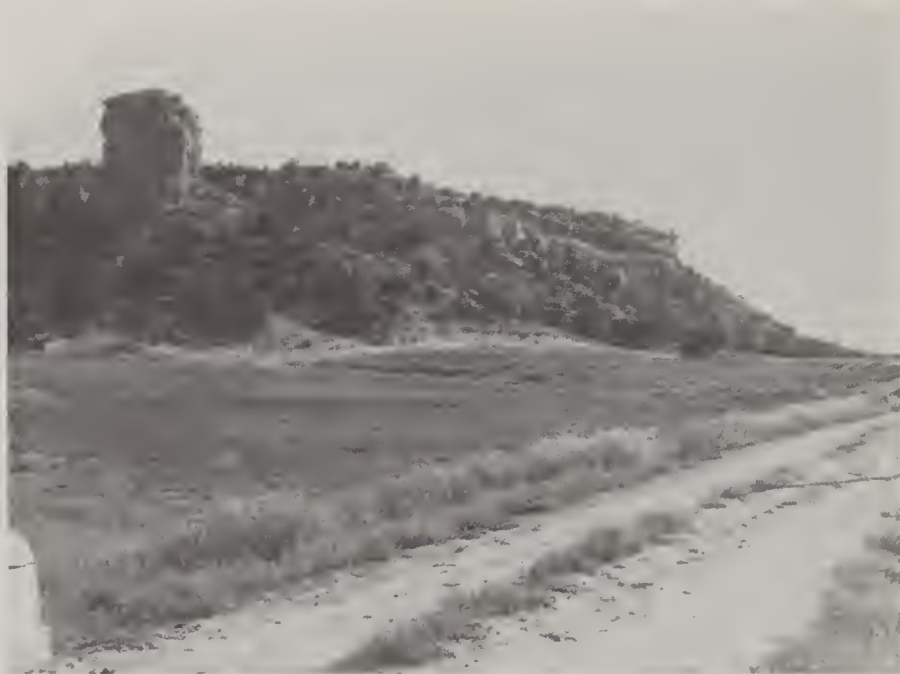
Photo 1-36. Debris basin, Navajo Indian Reservation, Apache County, Arizona. View shows sediment accumulations. The spillway is in stable rock.

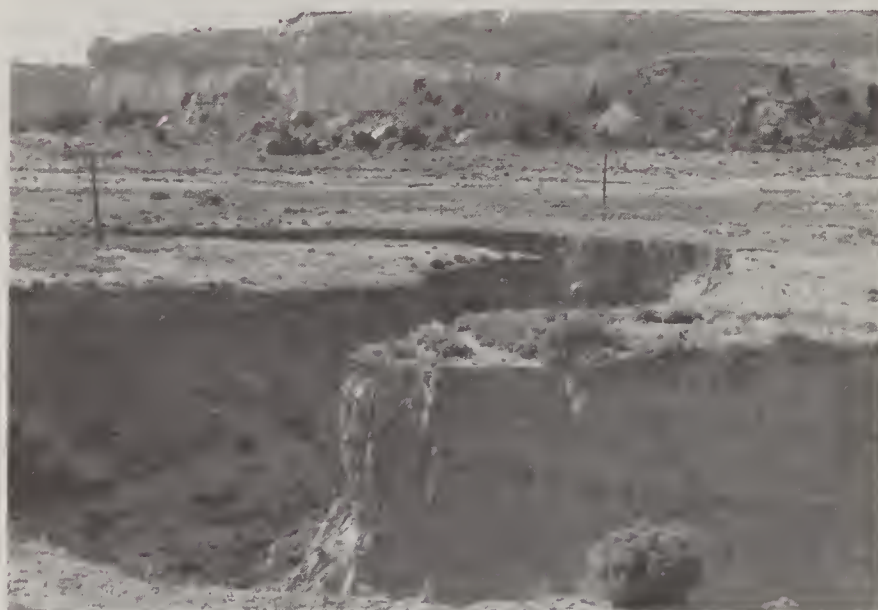
Photo 1-37. Gully downstream of debris basin shown in Photo 1-36. This scene (downstream) is in vivid contrast with that shown in Photo 1-36 (upstream).

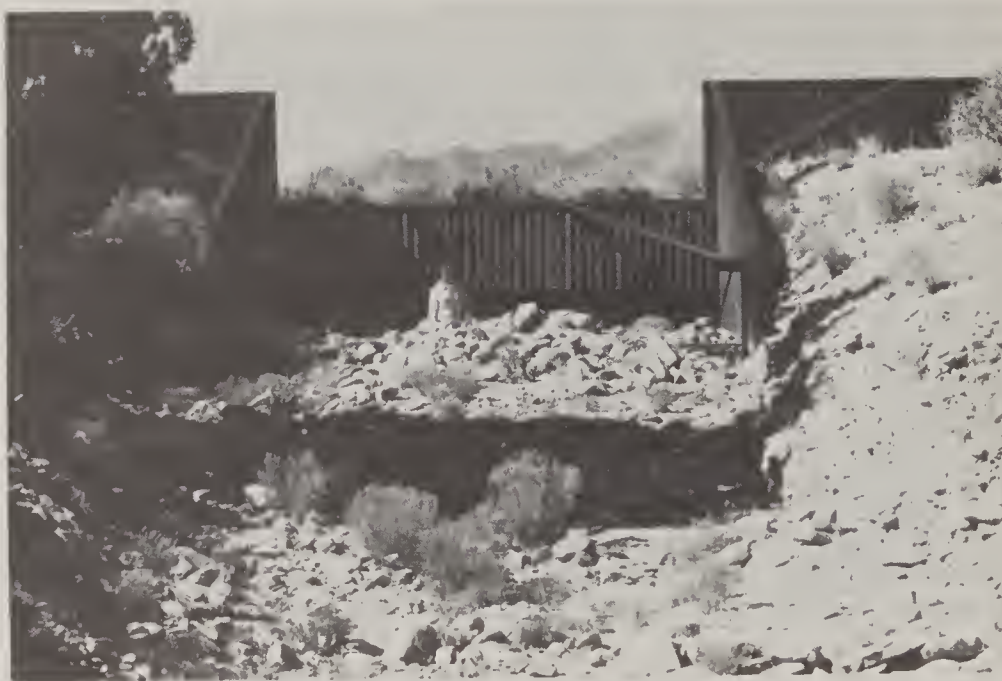
Photo 1-38. Steel drop structure (Elizabeth No. 1) constructed by Bureau of Land Management near Socorro, New Mexico. (Rio Grande River drainage)

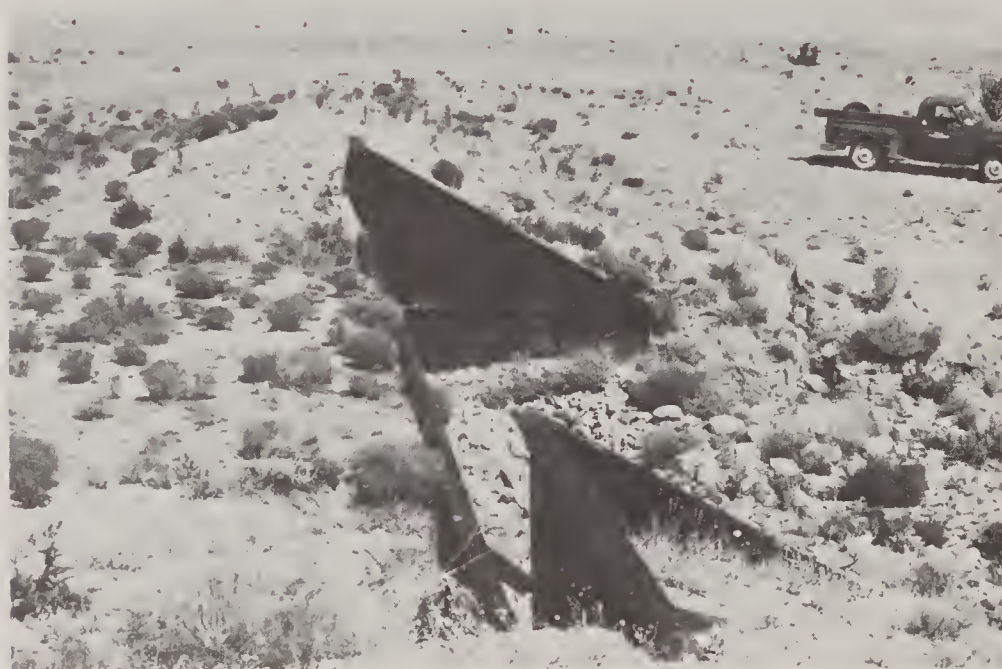
Photo 1-39. Steel drop structure (Elizabeth No. 2) constructed by Bureau of Land Management near Socorro, New Mexico. (Rio Grande River drainage)
